System Failure Case Studies

JANUARY 2008

Volume 2 Special Issue

REFINERY ABLAZE – 15 DEAD

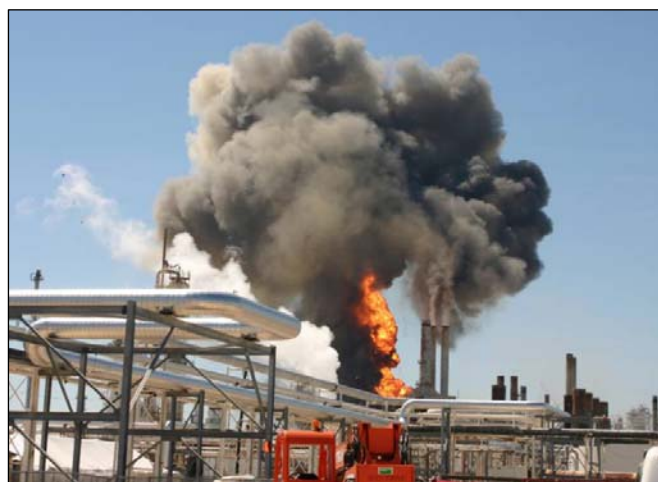
Blowdown stack emitting flames after explosion.

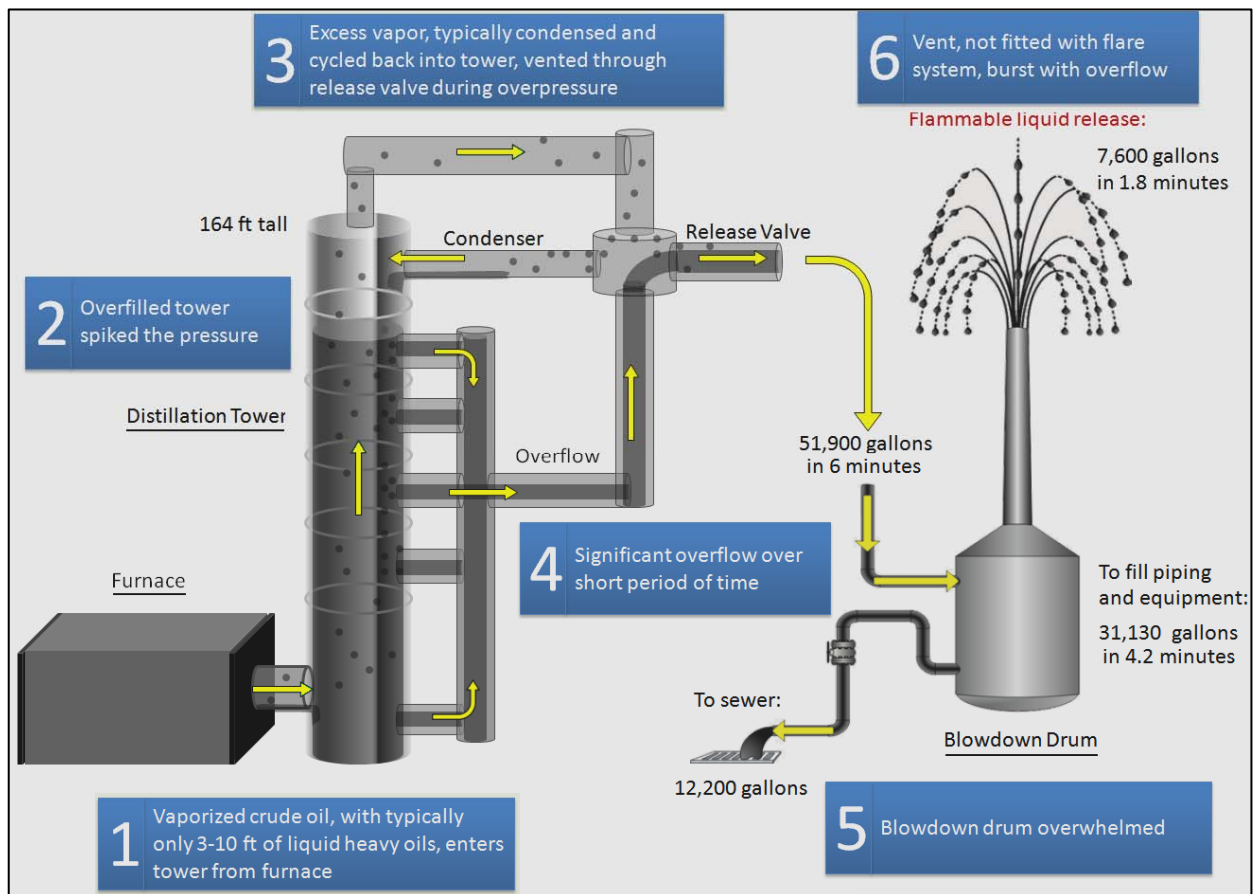
- Overfilling the distillation tower resulted in the overpressurization of the blowdown drum.

- Design lacked a flare on the vent stack and had an inadequate liquid level detection system.
- Failed operating procedures due to insufficient training and oversight.
- Deferred safety-related maintenance and ignored abnormal behavior from level detectors, control valves, and alarms.
- Proximity of trailers to hazardous sites.

The sequence of events that resulted in explosion, ignited by a nearby truck.
